BEST PRACTICES FOR IMPLEMENTATION OF TACK COAT: PART 2, FIELD STUDY

Research Report ICT-12-005

A report of the findings of
ICT-R27-100
Best Practices for Implementation of Tack Coat

Illinois Center for Transportation

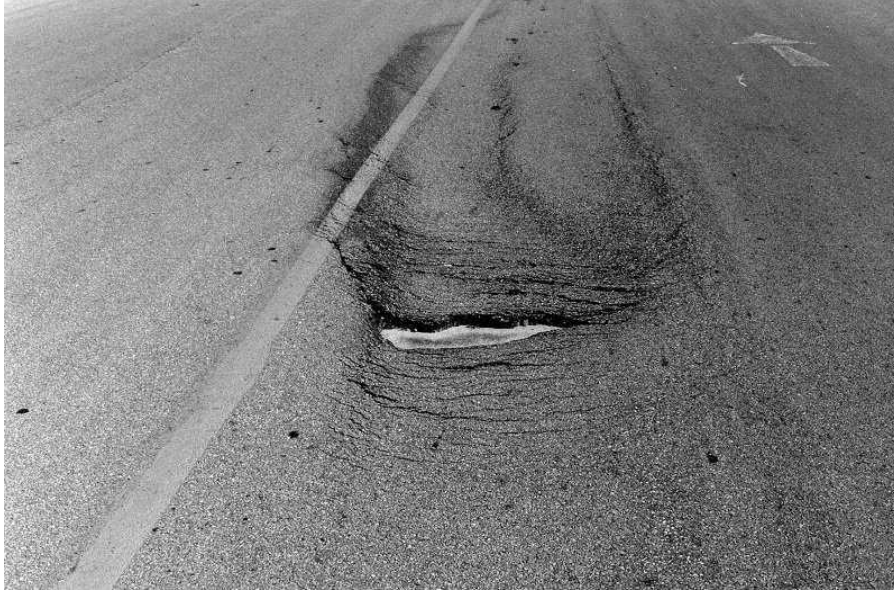
Figure 1.1. Slippage cracking (Asphalt Institute, n.d.).

The proper application of tack coat is an important quality-control parameter in paving projects. Several studies found that achieving maximum interfacial bonding requires an optimum application rate for the tack coat (Asphalt Institute, 1989). Under-applying tack coat material can cause insufficient bonding, resulting in debonding and fatigue cracking. Over-application of tack coat can introduce slippage of the upper layer, resulting in slippage cracking, and difficulties in compaction due to movement of the HMA under the heavy load of compactors, which contribute to a reduction in pavement life. Slippage cracking typically occurs at areas where braking or acceleration take place, resulting in slide or deformation of the overlay in a crescent or half-moon shape in the direction of traffic. Figure 1.1 shows a typical slippage crack problem. Slippage cracking can reduce the structural integrity of the pavement and increase the effect of the tire-applied shear stresses. These problems have a detrimental impact on ride quality.

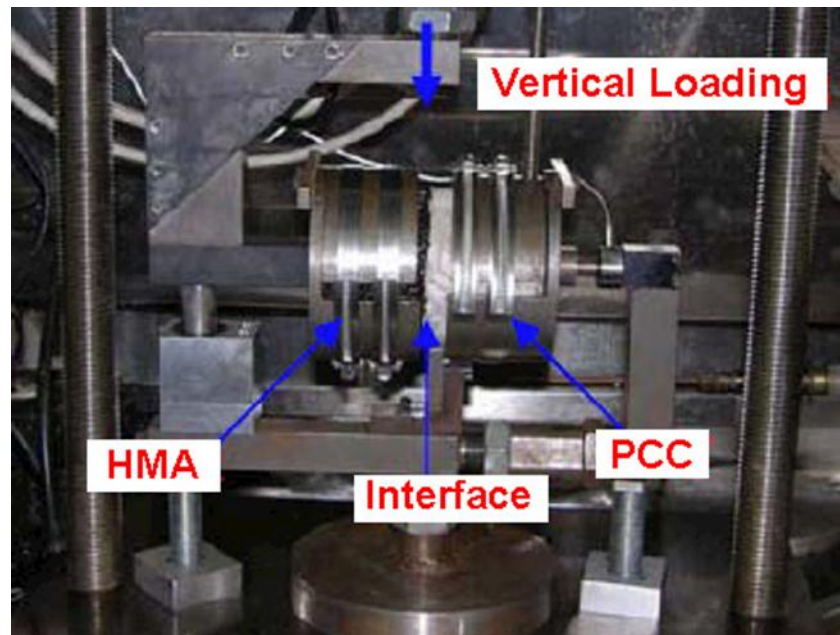
Figure 1.2. Direct-shear apparatus developed at ICT (Leng et al., 2008).

This device accommodates 3.94-in (100-mm) diameter specimens and can run both monotonic and cyclic loading tests. Shear interface strength was evaluated with a monotonic mode of loading at a constant displacement rate of 0.47 in/min (12 mm/min). The study found that the surface mix provided higher bonding strength than the binder mix. Asphalt emulsions showed a significant increase in shear strength compared to cutbacks; however, there was no significant difference between SS-1h and SS-1hp. The optimum residual application rate of the tack coat materials was 0.04 gal/yd² (0.18 L/m²). Moreover, milling was found to provide the highest shear strength, while tinning direction did not have a significant effect on interface bonding. Lowering the temperature increased the strength, but that might not be the case at extremely low temperatures (below the glassy transition temperature), where the brittle behavior of tack coat can decrease strength at the interface. Moisture conditioning severely decreased interlayer strength between HMA and PCC layers (Leng et al., 2008).

PCC cores. Asphalt mixes used in this study were SM-9.5 surface and IM-19.5A binder. Three tack coat materials were evaluated (SS-1h and SS-1hp emulsions and RC-70 cutback) and applied at residual rates ranging from no tack coat to 0.09 gal/yd² (0.405 L/m²). Tack coat was applied on different PCC surface textures (smooth, transverse tinning, longitudinal tinning, and milling). Bonding strength was also evaluated at various temperatures (50°F, 68°F, and 80°F; 10°C, 20°C, and 30°C) and under two moisture conditions, dry and saturated (Leng et al., 2008). The direct-shear testing device used in the ICT study is shown in Figure 1.2.

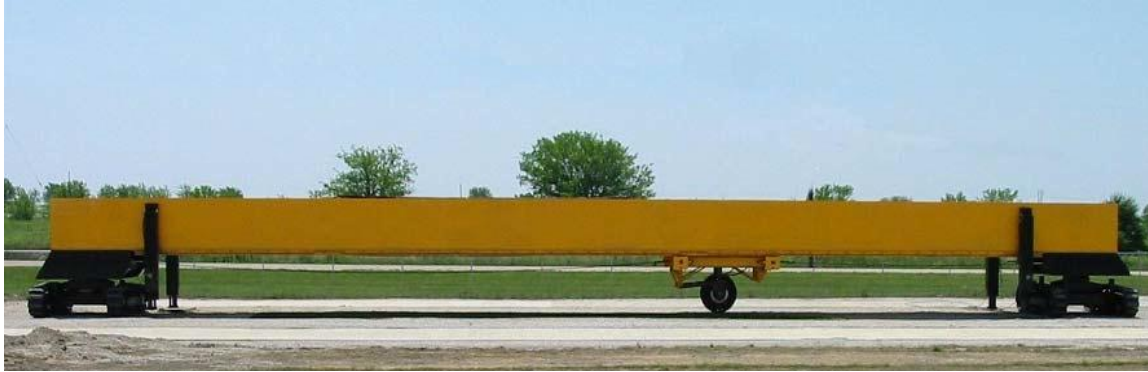
Figure 1.3. ATLAS machine (Leng et al., 2009).

To validate the laboratory results, accelerated paving testing was performed. Twenty-five sections were constructed and loaded with the Accelerated Transportation Loading ASsembly (ATLAS) machine at the centerline of the pavement (Leng et al., 2009). Figure 1.3 shows the ATLAS machine.

The tensile strain at the interface was measured (using H-type strain gauges) for selected sections to evaluate the potential for interfacial slippage. Primary rutting was also analyzed for different sections. Three tack coat materials (SS-1hp, SS-1h, and RC-70) were evaluated and applied at residual rates of 0.02, 0.04, and 0.09 gal/yd² (0.09, 0.18, and 0.405 L/m²). The asphalt binder PG 64-22 was also used and was applied at 0.04 gal/yd² (0.18 L/m²). Two cleaning methods were evaluated (broom cleaning and air blasting). Tack coat was applied over various PCC surface textures (smooth, milled, transverse, and longitudinal tinned).

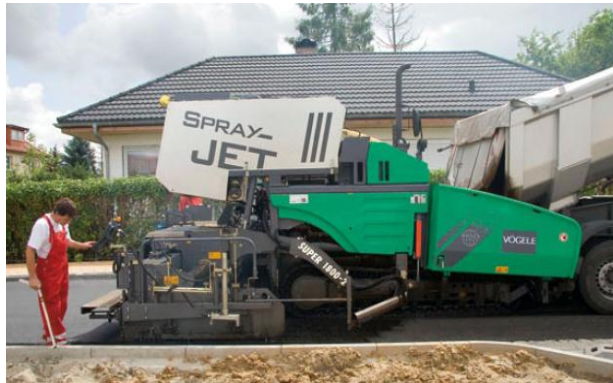
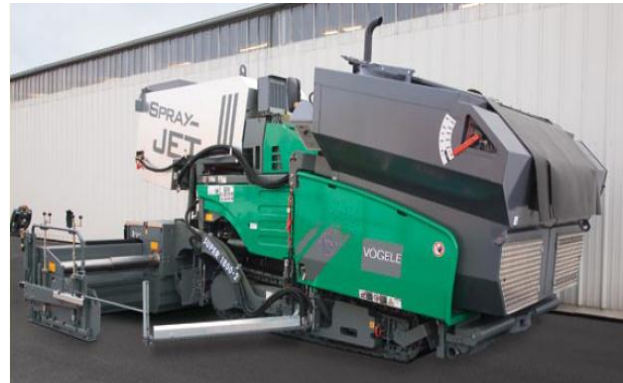
Figure 2.1. Spray jet module by Vögele (Vögele Wirtgen Group, 2009).

ensures complete surface coverage with tack coat, which reduces operating costs and increases productivity on a job site.

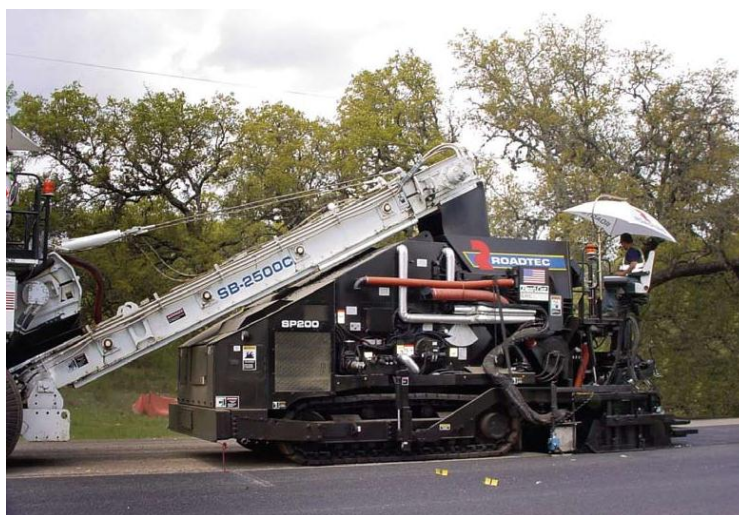
Figure 2.2. Spray paver by Roadtec (Roadtec, 2008).

This paver requires use of a material transfer vehicle to operate. However, it can also be used as a conventional paver without tack coat distribution to the surface. As discussed earlier, many economic advantages can accrue from using such equipment. Accordingly, the interface bonding achieved by this machine was analyzed in the field evaluation.

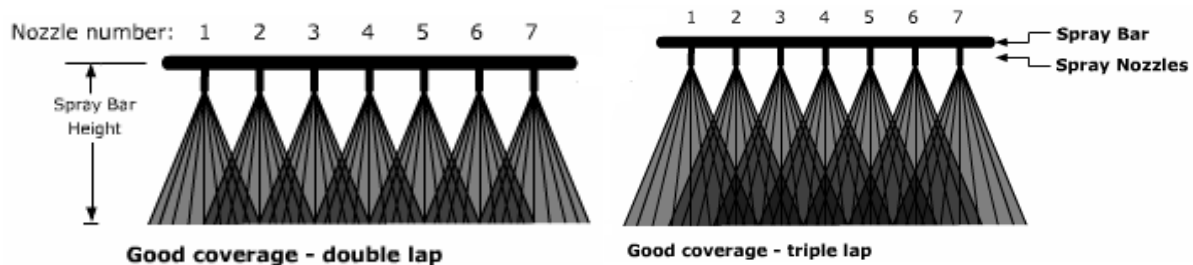
Figure 2.3. Correct application of tack coat (Mohammed and Button, 2005).

The best uniformity of tack coat is achieved by overlapping the material, as shown in Figure 2.3. The surface over which the tack coat is applied must be completely clean and free of moisture, in order to achieve desired interface bonding.

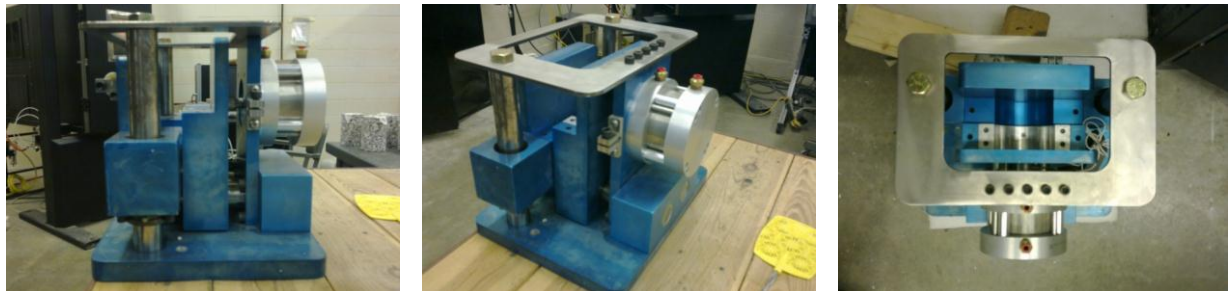
Figure 3.1. Interface Shear Test Device (ISTD).

The Interface Shear Test Device (ISTD), as shown in Figure 3.1, was custom-designed to evaluate bonding strength between pavement layers. The ISTD evaluates tack coat bonding between HMA layers and HMA-PCC layers. It measures the change in shear loading, dilation, and shear displacement.

The mechanism of testing depends primarily on three parts of the device: the shear load stroke, the normal pressure load cell, and the specimen housing chamber. Two load cells, 10 and 22 kips (44 and 97.8 kN), were used for this test. This permits consideration of high shear loading between layers when relatively high normal pressure is applied. An air-pressure actuator connected to a miniature load cell with a capacity of 2 kips (8.9 kN) was used as a normal pressure system to simulate vertical loading at the interface due to tire contact pressure on the pavement surface.

This device allows both static and dynamic normal loads to be applied on the specimen. The housing chamber holds the specimen steady during testing. The device can accommodate 3.93- and 5.90-in (100- and 150-mm) diameter specimens with heights ranging from 3.7 to 4.3 in (94 to 109 mm). To allow dilation during the test, it is recommended that specimens be between 3.70 and 3.86 in (94 and 98 mm) long. If the specimen is too short, steel fillers with the same diameter as the specimen can be used to align the interface in the middle of the gap, where shear is applied. Two linear variable differential transducers (LVDTs) were used to measure both shear displacement and dilation. Dilation is defined as enlargement of the specimen at an axis perpendicular to the shear load direction.

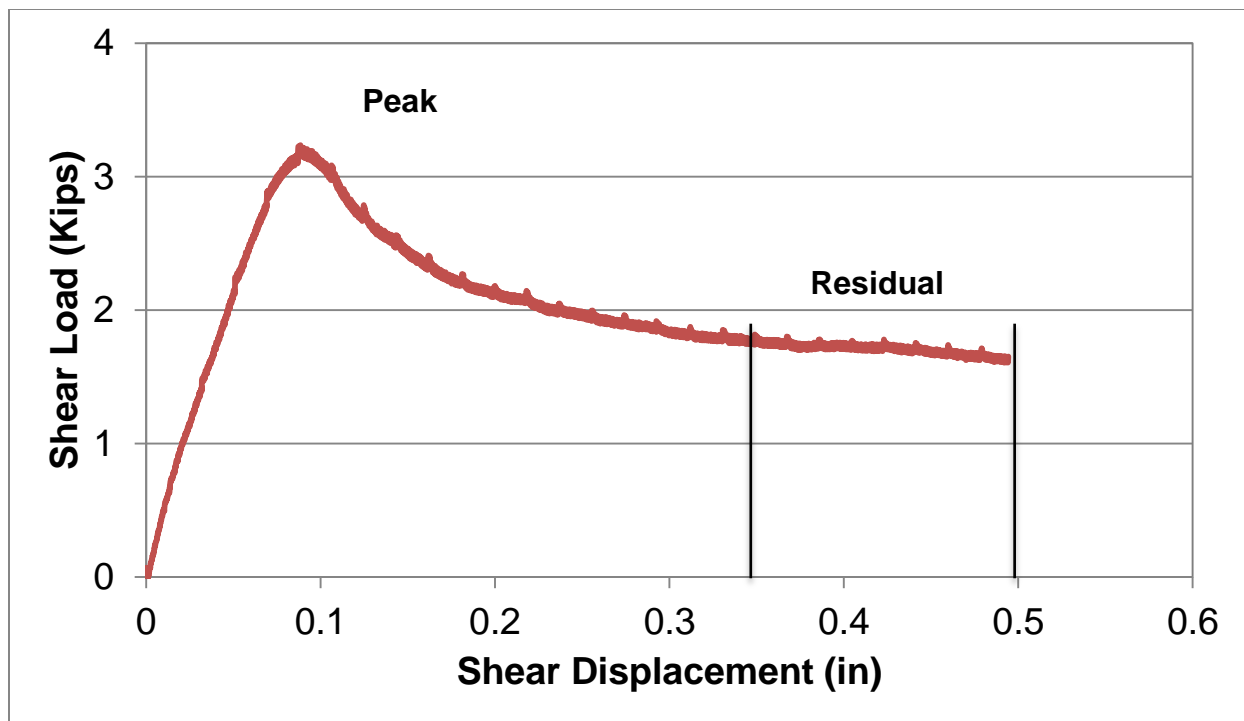
Figure 3.2. Typical shear load–displacement curve.

The dimensions of the device allow specimens to be placed into a servo-hydraulic testing machine. Tests can be conducted in a monotonic loading mode that measures maximum shear load and its corresponding shear displacement to evaluate interface strength. In addition, this device can be used to perform fatigue shear tests by applying cyclic loads at desired frequencies to better simulate field conditions. Both test modes can be conducted with either constant loading or displacement rates at various normal loading levels. In monotonic testing mode, shear load, and displacement are measured along with testing time. Results can be presented as a relationship between shear strength and displacement. Figure 3.2 illustrates a typical load-displacement curve at 20 psi (0.137 MPa) normal pressure.

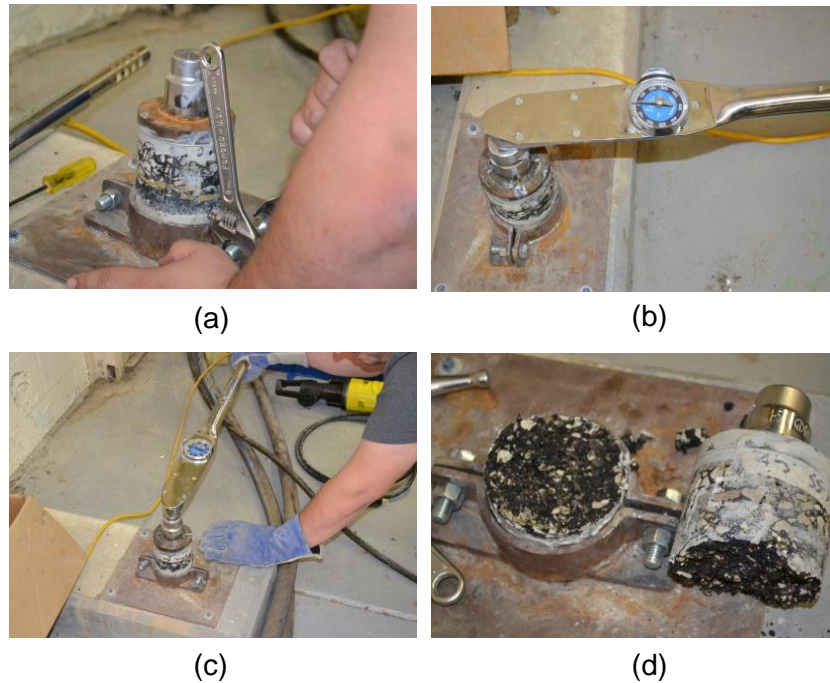
Figure 3.3. Torque bonding test: (a) Clamping the specimen, (b) Setting the torque device, (c) Applying torque to the specimen, and (d) Tested specimen.

For the laboratory-performed test, it is important to extract the core at least 3.15 in (80 mm) below the interface, without damage. In the lab, specimen preparation includes cutting the core to a specific height to ensure that the interface extends at least 0.787 ± 0.394 in (20 ± 10 mm) above the rim of the mold. The metal plate was fixed to the mold with adhesive material. The core was conditioned for a minimum of 4 hr, but not more than 16 hr, at a temperature of 68°F ± 4°F (20°C ± 2°C). The core was placed in the mold and fixed, after which point the test was performed. Figure 3.3 depicts all steps of the torque bond test.

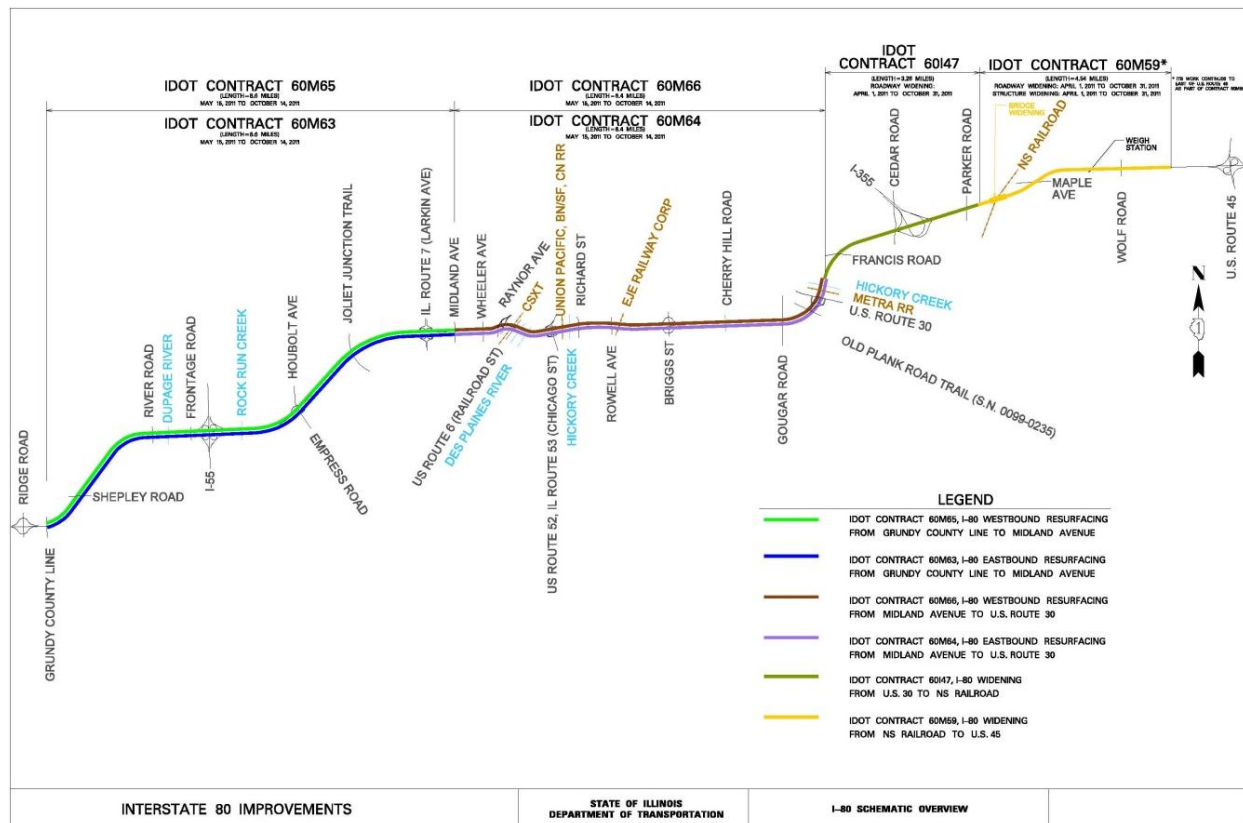
Figure 3.4. Interstate 80 project diagram.

In April 2011, the Illinois Department of Transportation (IDOT) initiated a project for improvements of a 22-mi (35.41-km) portion of I-80. The work consists primarily of resurfacing and adding a third lane. Resurfacing is planned for the portion of I-80 from the Grundy County line to U.S. Route 30. The project also includes rehabilitation of 29 bridges and resurfacing of all ramps and interstate shoulders along that portion. A third lane will be added in each direction from U.S. Route 30 (Lincoln Highway) to U.S. Route 45 (LaGrange Road) to improve traffic flow and safety, especially in the region of the I-80/I-355 interchange. In addition, IDOT plans to build noise walls in certain locations, construct median shoulders along both sides of I-80, and perform drainage and bridge-widening work. Figure 3.4 is a map of the project.

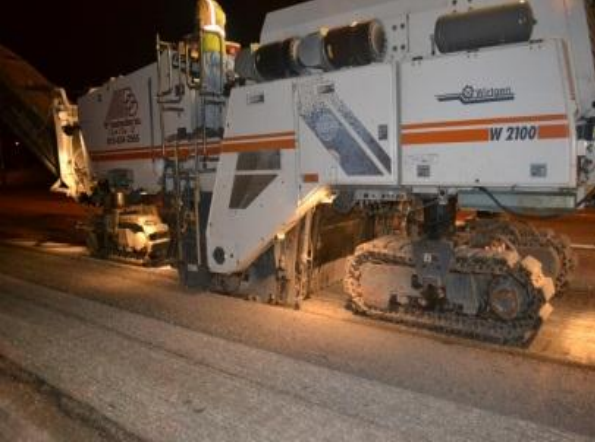
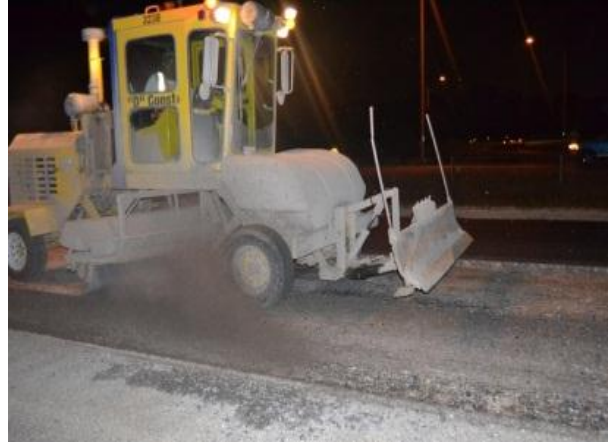
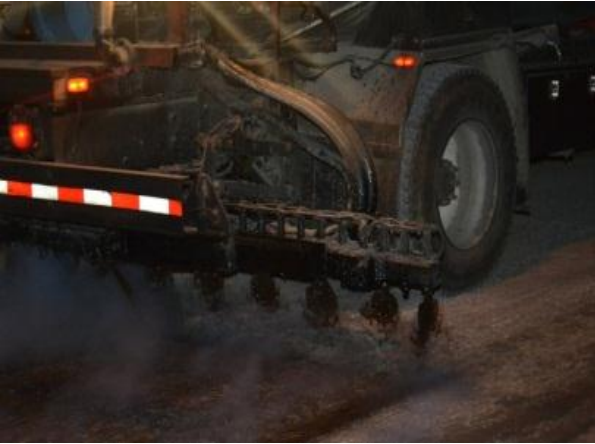
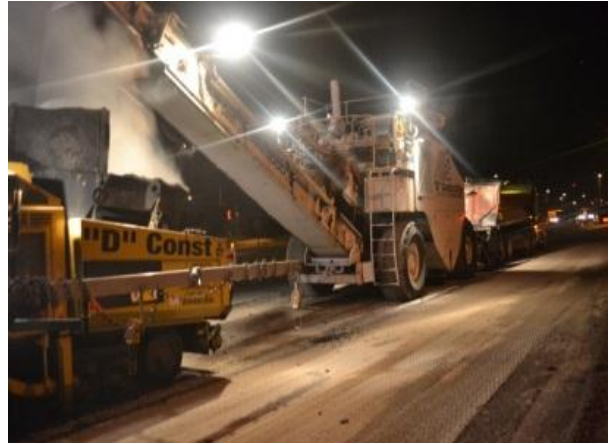
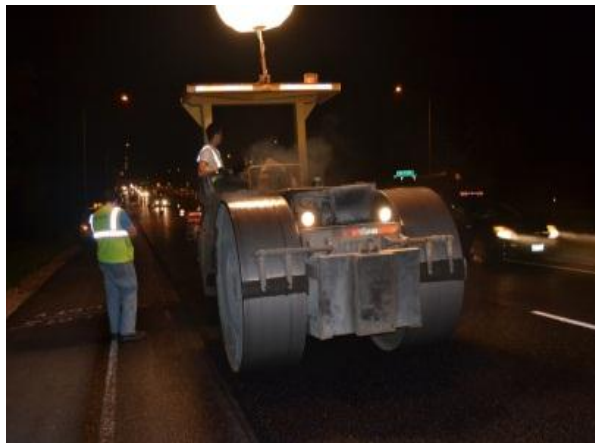
Figure 3.5. Construction process on I-80 project: (a) Milling, (b) Cleaning, (c) Tack coat application, (d) Paving, and (e) Compaction.

Construction on I-80 was performed during the night. It consisted of milling 4 in (10.16 cm) of an asphalt layer and replacing it with 2 in (5.08 cm) of binder SMA mix and 2 in (5.08 cm) of surface SMA mix. The construction process started with milling the asphalt, then cleaning was done using a broom and vacuum equipment. After cleaning, the tack coat was applied by a distributor truck at a specified residual rate. The overlay was placed in two layers—first, 2 in (5.08 cm) of binder SMA mix, and then 2 in (5.08 cm) of surface SMA mix. Compaction was conducted by three static rollers, and the smaller roller being used to finalize the compaction. The targeted air voids for both mixes was 3.5%. Figure 3.5 shows the construction process for this project.

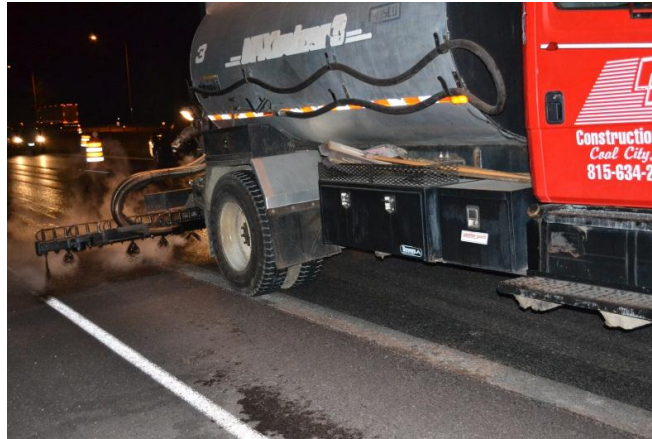
Figure 3.6. Tack coat application with distributor truck.

In this project, the tack coat was applied using a distributor truck, as shown in Figure 3.6. The tack coat application temperature was 170°F (76.7°C) for SS-1h and 175°F (79.4°C) for SS-1vh. The tack coat residual application rate was verified in-situ using geotextile squares (1 × 1 ft; 0.3048 × 0.3048 m). This verification was performed at the beginning of each day of work as part of the quality assurance (QA) process.

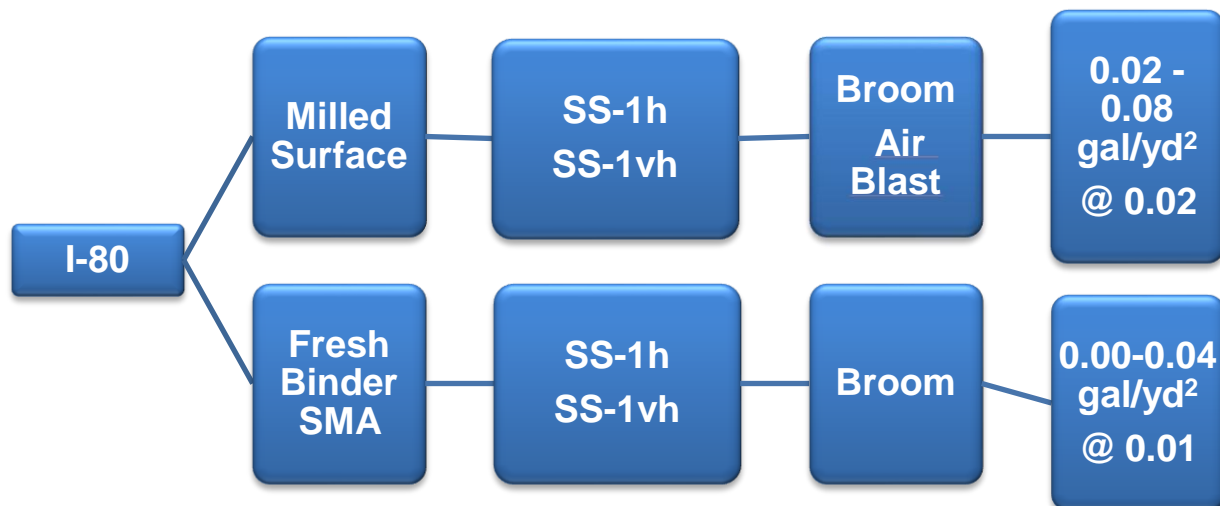
Figure 3.7. Testing matrix for I-80 project.

The field study evaluated the effect of various parameters that influence bonding between pavement layers, including application rate, interface texture, surface mix type, surface cleanliness, curing time, and tack coat type. The testing matrix is shown in Figure 3.7. For the I-80 project, SS-1hp and SS-1vh tack coat materials were applied at a range of residual rates from 0.02 to 0.08 gal/yd² (0.09 to 0.36 L/m²) at intervals of 0.02 gal/yd² (0.09 L/m²). Figure 3.8 illustrates the test pavement sections plan for this project.

Two cleaning methods (broom and air blast) were used in the evaluation of both tack coat materials. For these 16 sections, polymer SMA binder mix N80 was paved after applying tack coat. Five more sections for each tack coat material (10 sections in total) at five various rates (0, 0.01, 0.02, 0.03, and 0.04 gal/yd²) (0, 0.045, 0.09, 0.14, and 0.18 L/m²) were applied to evaluate the optimum residual application rate on top of new HMA. In these sections, polymer SMA 12.5-mm surface mix N80 was paved as an overlay on top of unmilled new HMA.

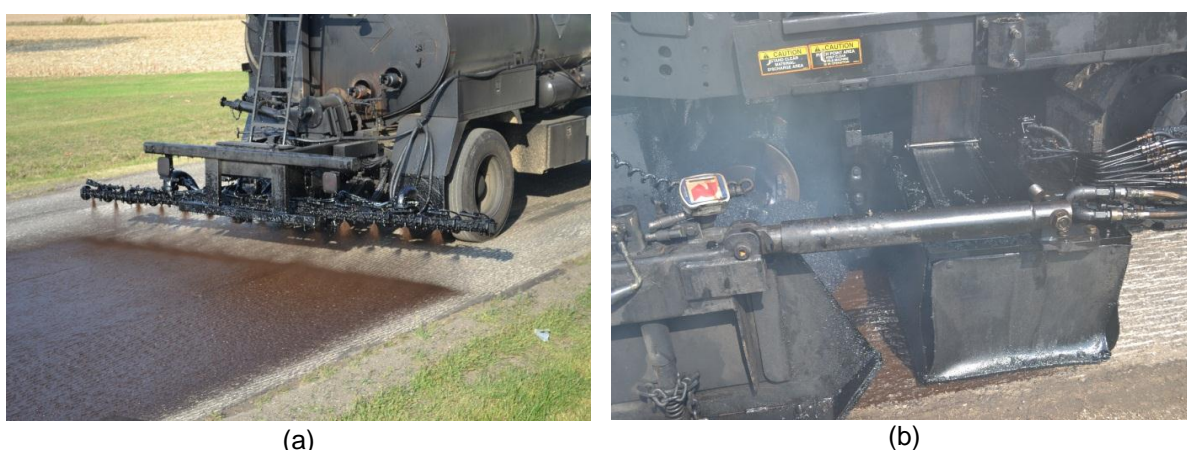
Figure 3.11. (a) Tack coat application with distributor truck, (b) Tack coat application with spray paver.

In this project, the tack coat was applied using a distributor truck and a spray paver, as shown in Figure 3.11. The tack coat application temperature was 170°F (76.7°C) for SS-1h and SS-1hp and 175°F (79.4°C) for SS-1vh. The tack coat residual application rate was verified in-situ using geotextile squares (1 × 1 ft; 0.3048 × 0.3048 m). This verification was done at the beginning of each day of work as part of the quality assurance (QA) process for equipment performance.

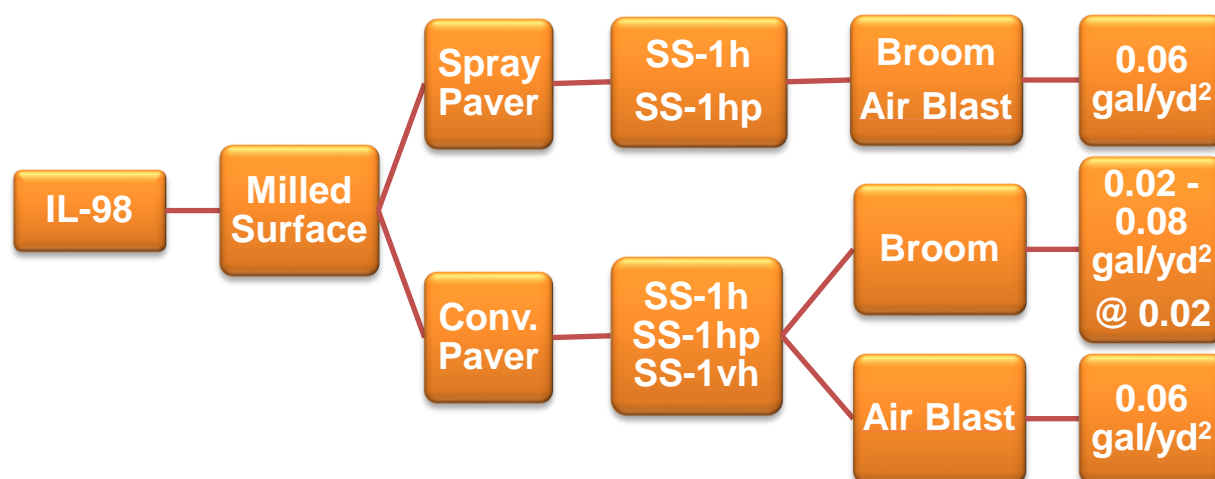
Figure 3.12. Test matrix for IL-98 Project.

The IL-98 Project included 19 sections that were constructed to evaluate the performance of three tack coat materials (SS-1h, SS-1hp, and SS-1vh). The tack coats were applied at a residual rate ranging from 0.02 to 0.08 gal/yd² (0.09 to 0.36 L/m²) at intervals of 0.02 gal/yd² (0.09 L/m²), as shown in Figure 3.12. The tack coat was applied over a milled HMA surface. Figure 3.13 shows the construction plan for this project.

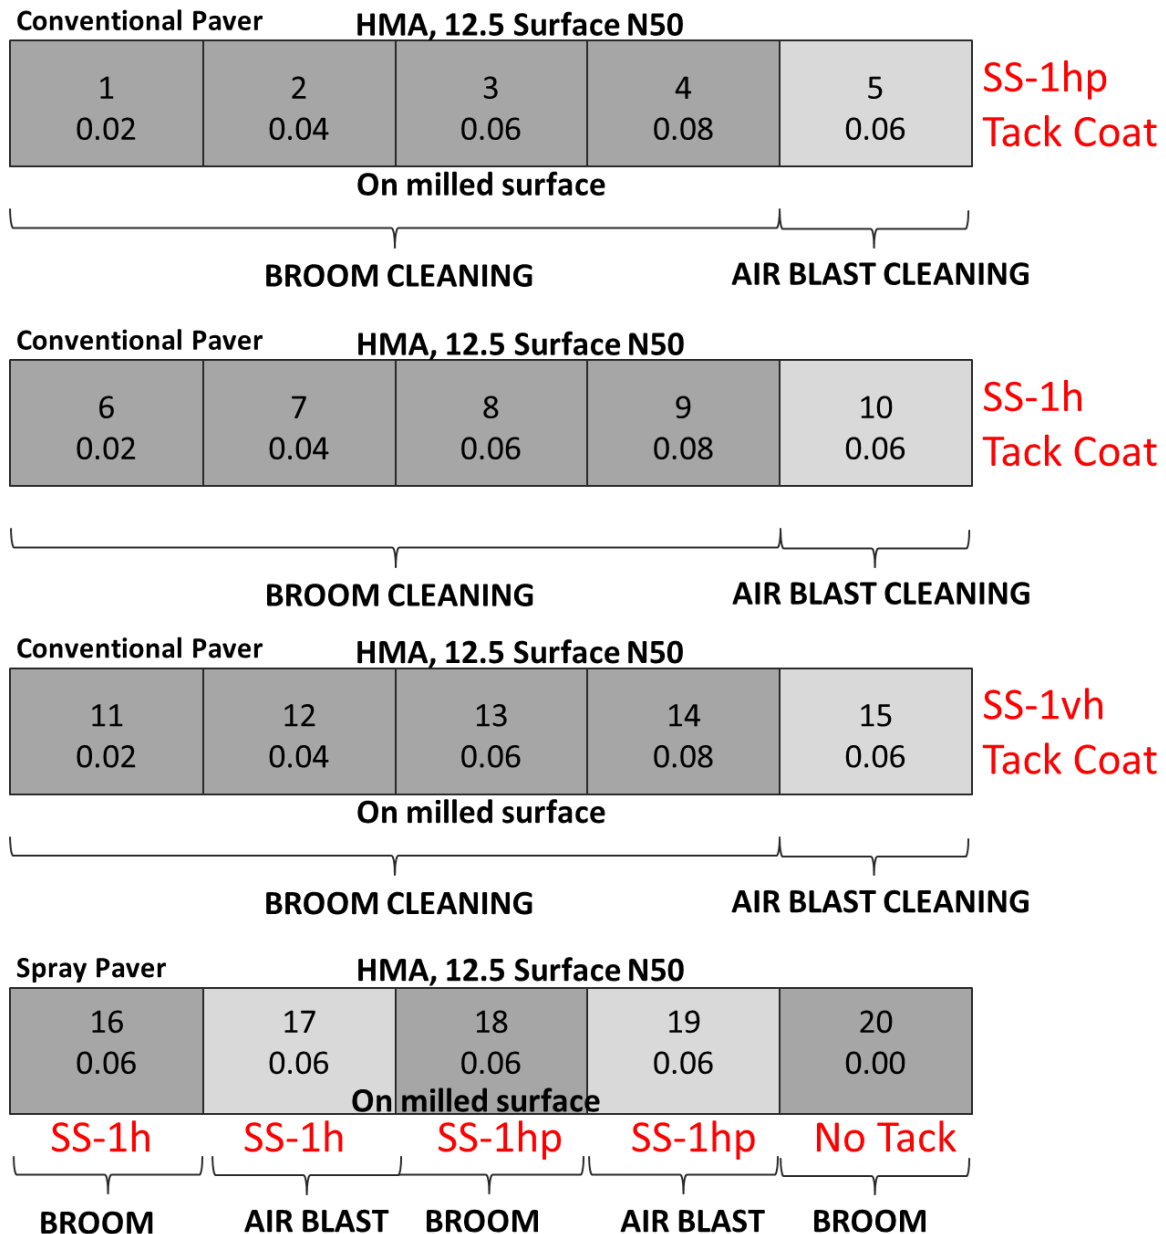
Figure 3.13. Field construction plan for IL-98 Project: HMA 12.5 surface N50 mix on top of milled surface.

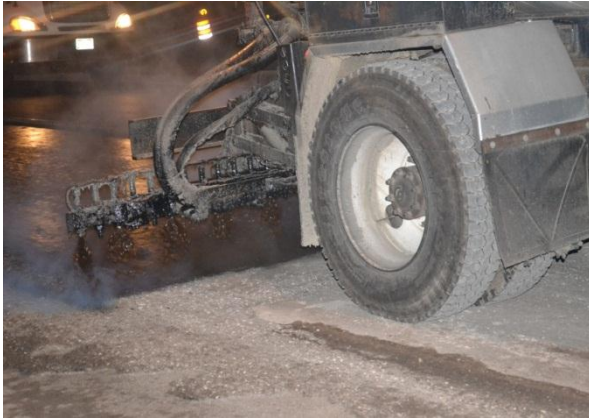
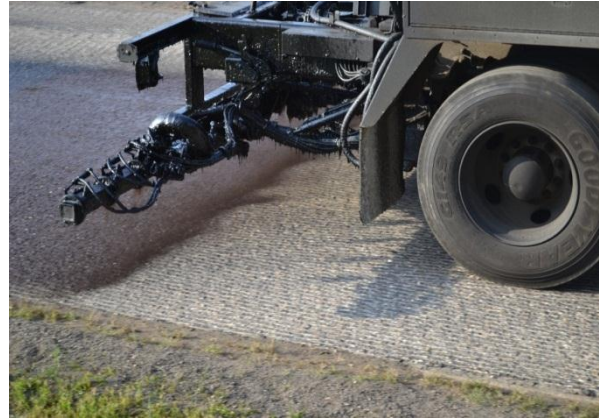
Figure 3.14. SS-1vh application with the distributor truck: (a) I-80 project and (b) IL-98 project.

- In the I-80 Project, problems were encountered with distribution of the non-track tack coat. The distributor truck was clogged for several days, requiring major repair. To avoid a clogging problem, the tack coat must be maintained at a constant temperature of 175°F (79.44°C). This problem was not experienced on the IL-98 Project. After the problem was corrected, the distributor truck was used in both projects for the tack coat application, as shown in Figure 3.14.

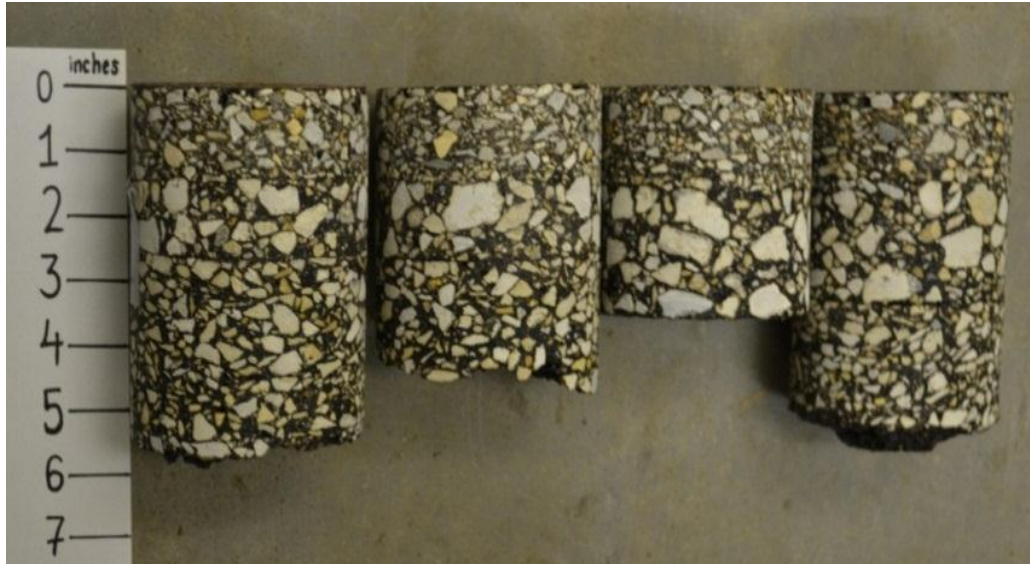
Figure 4.1. A sample of cored specimens from the IL-98 project.

The composite specimens were cored from the field at least 24 hr after construction to allow for maximum curing of the HMA. The specimens were cored at a 4-in (100-mm) diameter and were obtained from wheel paths and the centerline to examine any difference in performance due to trafficking during construction. Coring was performed slowly to avoid breaking the interface by the rotational force of the coring machine. In addition, slow coring helped the operator maintain a vertical coring direction, resulting in better specimens. Figure 4.1 shows a sample of cored specimens from IL-98 project.

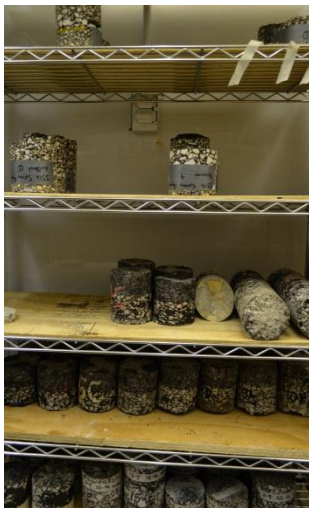
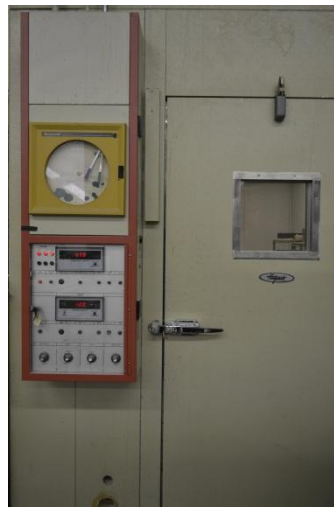
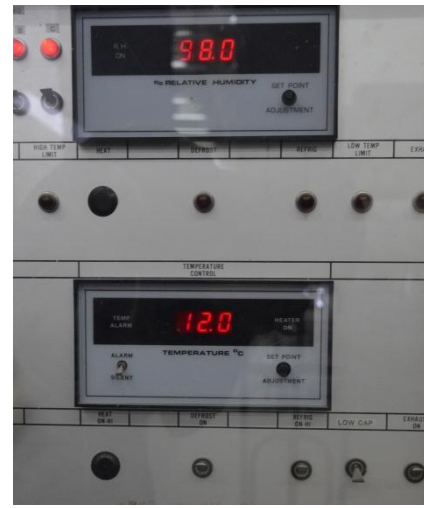
Figure 4.2. (a) Specimens storage inside the climatic room, (b) Climatic storage room, and (c) Temperature controlled at 53.6°F (12°C).

The specimens were labeled, dried, and transported to the lab, where they were stored at 53.6°F (12°C) to avoid creep of HMA (Figure 4.2). The specimens had to be cut at specific dimensions to fit inside the specimen housing chamber in the testing device. The interface was visually marked using yellow crayon, as shown in Figure 4.3. The required height was marked and the specimen cut to a length of 3.77 to 3.86 in (96 to 98 mm) for ISTD specimens and 4.53 to 4.72 in (115 to 120 mm) for torque test specimens using a water-cooled 5-mm-blade saw, as shown in Figure 4.4.

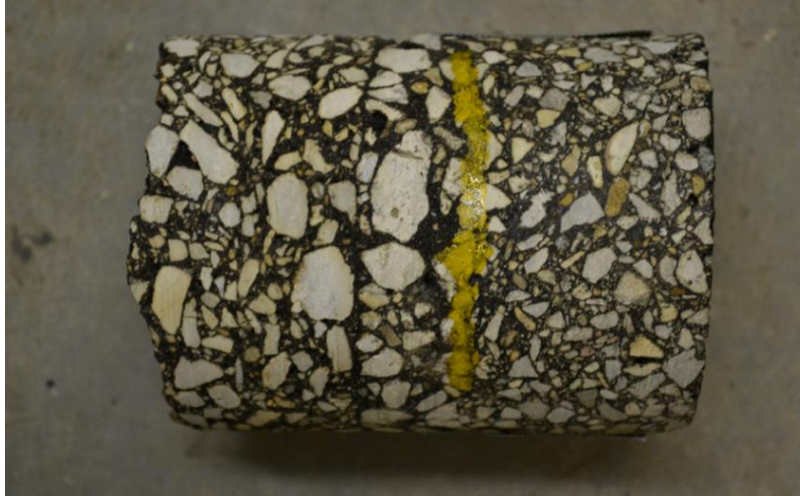
Figure 4.3. Interface labeled with yellow crayon.

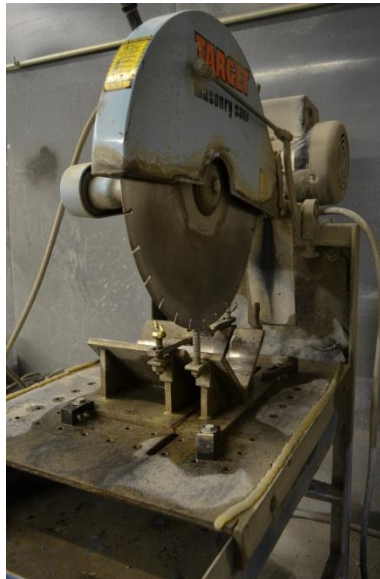
Figure 4.4. Water-cooled 5-mm-blade saw.

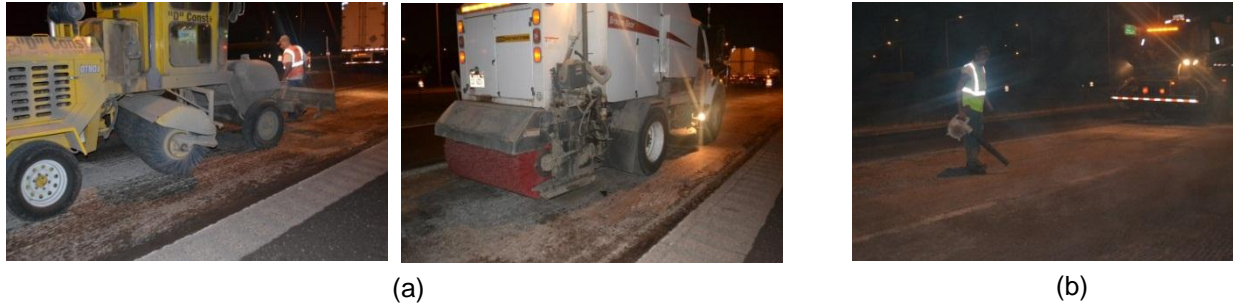
Figure 5.1. Cleaning methods: (a) Broom and vacuum, (b) Air blast.

in an urban area where the dust cloud can be hazardous. The method is also time consuming, which reduces work efficiency. The cleaning process used in this study is shown in Figure 5.1.

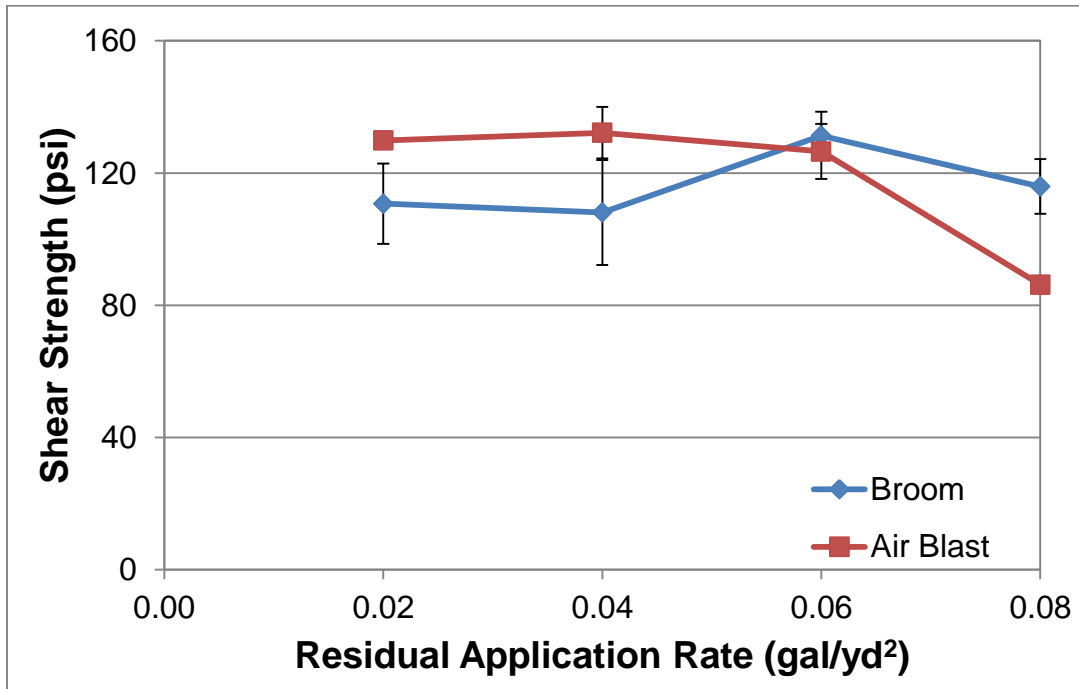
Figure 5.2. Shear strength for milled HMA using SS-1h as tack coat.

Shear and torque tests were performed on the specimens that were cored after construction. The results exhibited some variability between cores, based on different cleaning methods, as shown in Figure 5.2. According to the results of the ISTD on the milled HMA surface, the SS-1h tack coat showed similar behavior at the optimum tack coat application rate, regardless of cleaning method. At the lower application rate, air-blast cleaning showed greater shear strengths; however, when the application rate was higher than the optimum, the broom cleaning method showed greater shear strength because the remaining dust reduced the effective tack coat rate. The optimum residual application rate is 0.06 gal/yd² (0.27 L/m²) for broom cleaning, while for air-blast cleaning the optimum rate was reduced to 0.04 gal/yd² (0.18 L/m²). Hence, air blasting can reduce the optimum application rate for milled HMA using SS-1h as tack coat.

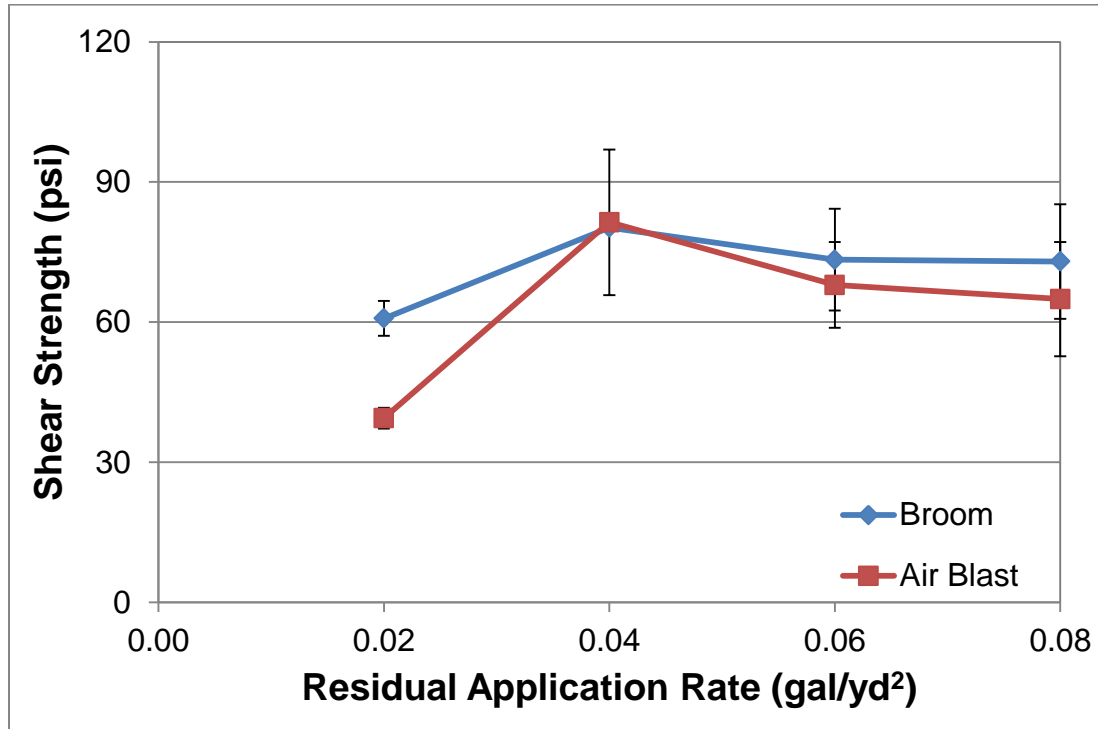
Figure 5.3. Shear strength for milled PCC using SS-1vh tack coat.

In the case of SS-1vh over milled PCC using the ISTD, the difference between cleaning methods was not critical (as illustrated in Figure 5.3). The broom and air-blast cleaning methods produced similar results, and the optimum rate obtained for both methods was 0.04 gal/yd² (0.18 L/m²), which is in agreement with an earlier study by Al-Qadi et al. (2009).

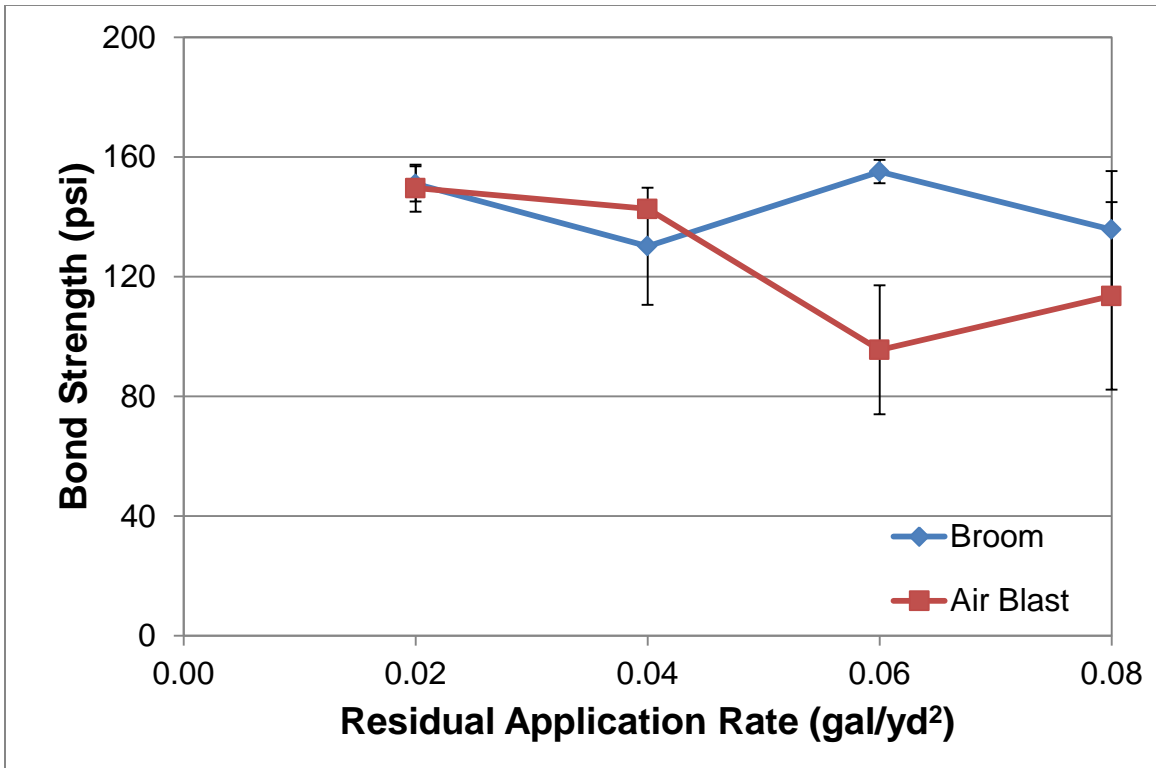
Figure 5.4. Bond strength for milled HMA using SS-1h tack coat.

The torque bond test showed trends similar to the ISTD. The maximum bond strength attained, when all application rates of SS-1h were considered, was the same for both cleaning methods in the case of milled HMA. However, optimum application where maximum bond strength was attained is different for each cleaning method. Figure 5.4 illustrates these results for SS-1h on milled HMA surface. Similar to the results of the ISTD, air blasting reduced the optimum application rate from 0.06 gal/yd² (0.27 L/m²) to 0.04 gal/yd² (0.18 L/m²). On the other hand, the broom-cleaning method yielded the best bond strength at 0.08 gal/yd² (0.36 L/m²) with SS-1vh tack coat over PCC, whereas the air-blast method yielded maximum bond strength at 0.06 gal/yd² (0.27 L/m²) for the same materials and surface type, as seen in Figure 5.5. It is important to note that both test results showed a similar trend of reduction in the application rate when air-blast cleaning was used, compared to broom cleaning only. Hence, air blasting does not improve interface bonding; however, it can reduce the amount of tack coat needed to achieve the best bond between layers.

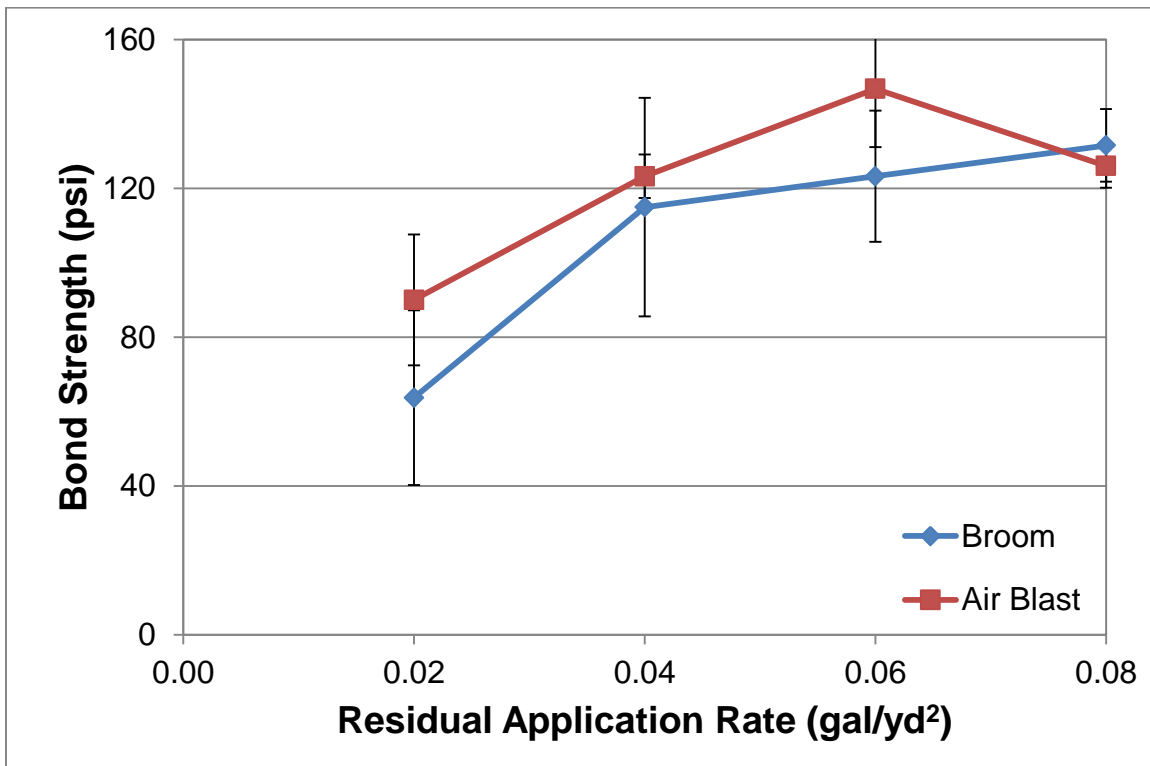
Figure 5.5. Bond strength for milled PCC using SS-1vh tack coat.

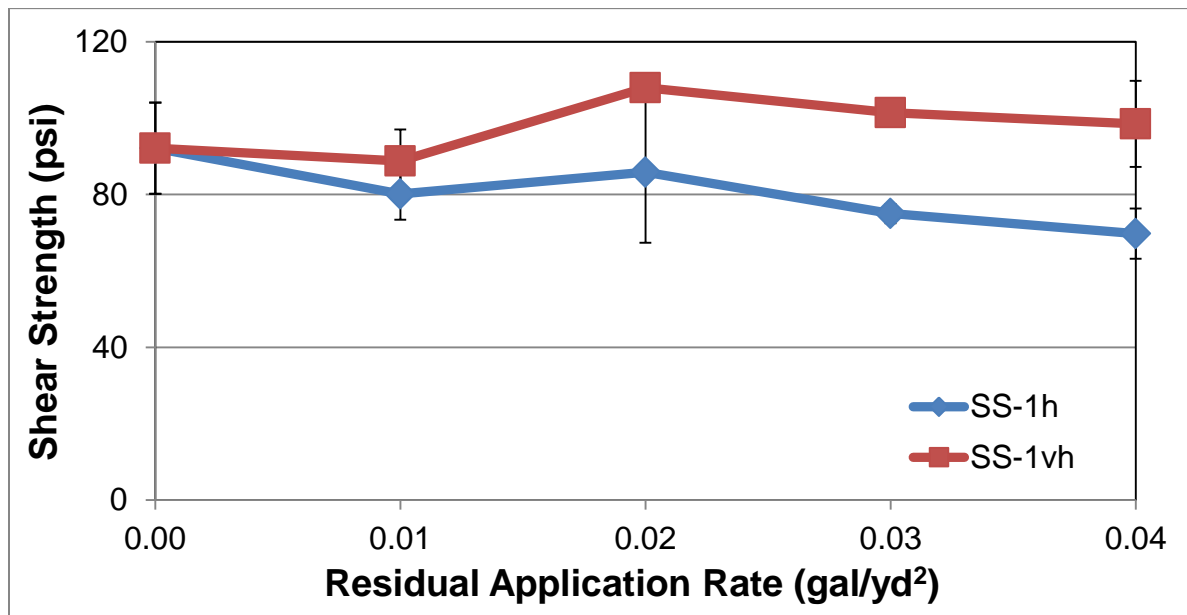
Figure 5.6. Shear strength for surface SMA on top of fresh binder SMA.

Two tack coat materials were analyzed: SS-1h and SS-1vh. As illustrated in Figure 5.6, the results of the ISTD showed that SS-1vh performs better than SS-1h at each application rate. For bond strength, a similar trend was observed. Therefore, the use of SS-1vh as tack coat material is recommended.
